Changes in IV characteristics of a PV module with interconnects that are failing during cyclic mechanical loading

Hubert Seigneur¹, Jason Lincoln¹, Eric Schneller², Joseph Walters¹

¹ Florida Solar Energy Center, University of Central Florida, Cocoa, FL USA

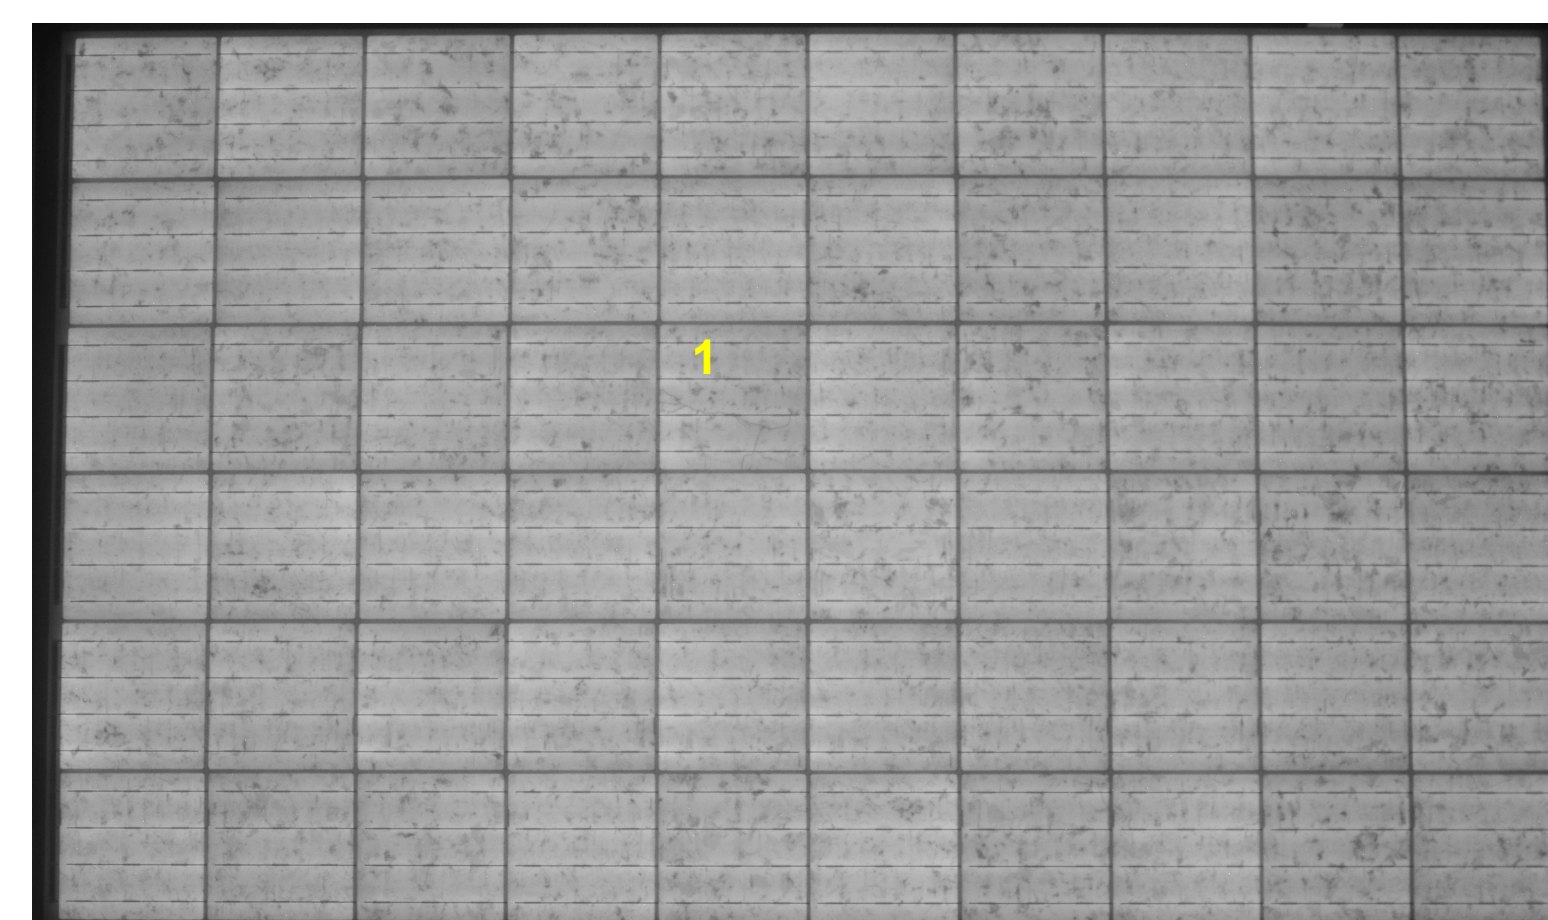
Figure 2. EL image at 0Pa after 5 cycles. Crack occurred after 5¹ cycles

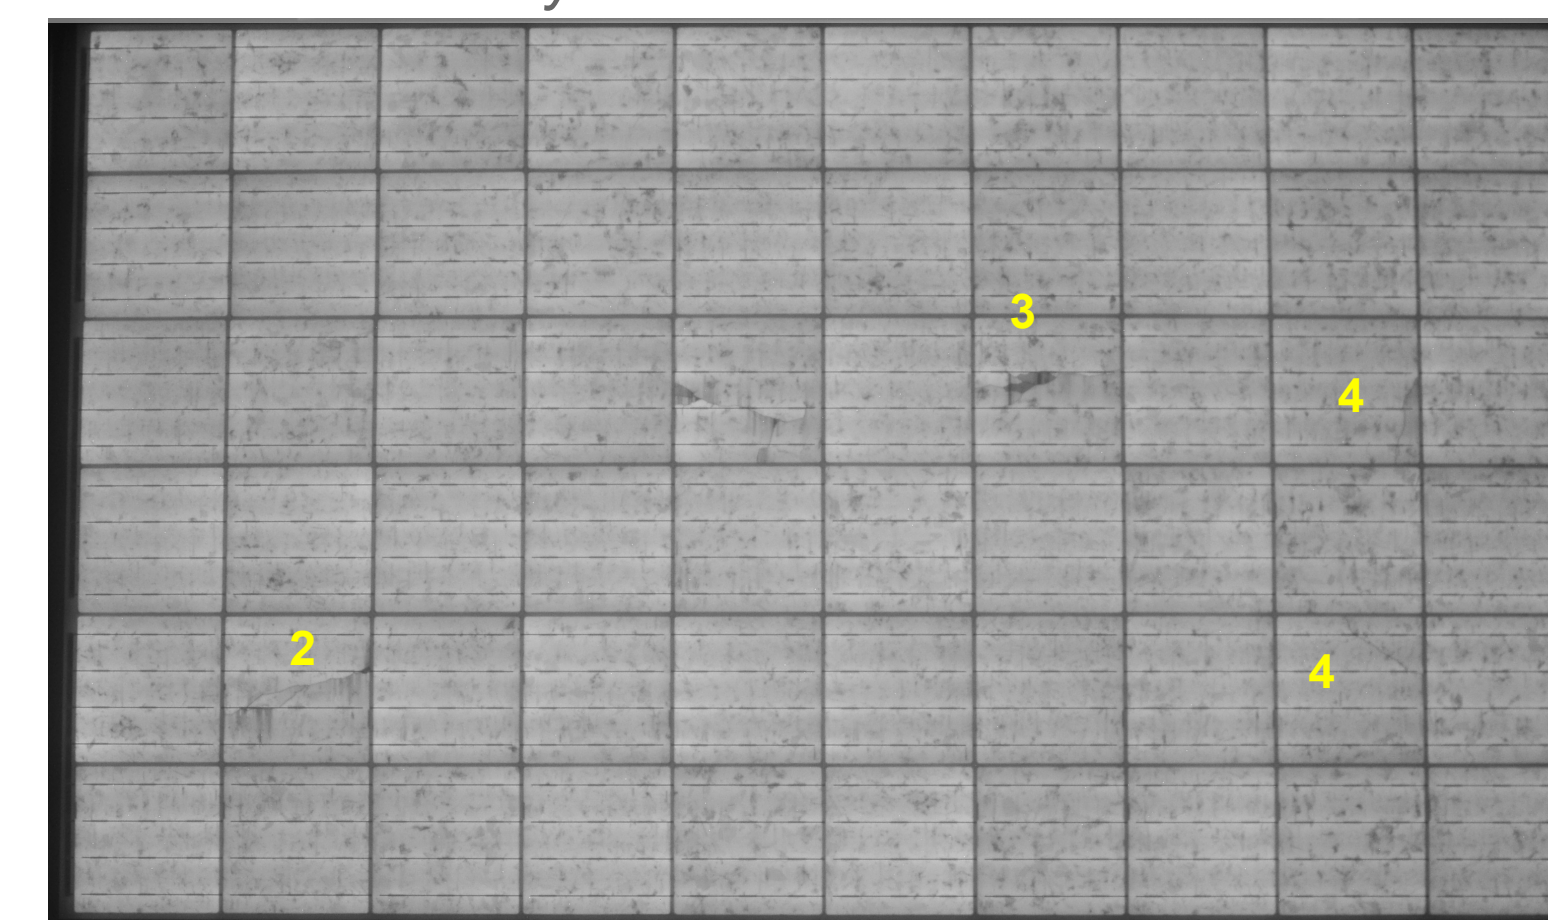
Figure 3. EL image at 0Pa after 10,000 cycles. Cracks occurred after 2000², 5000³, 9000⁴ cycles.

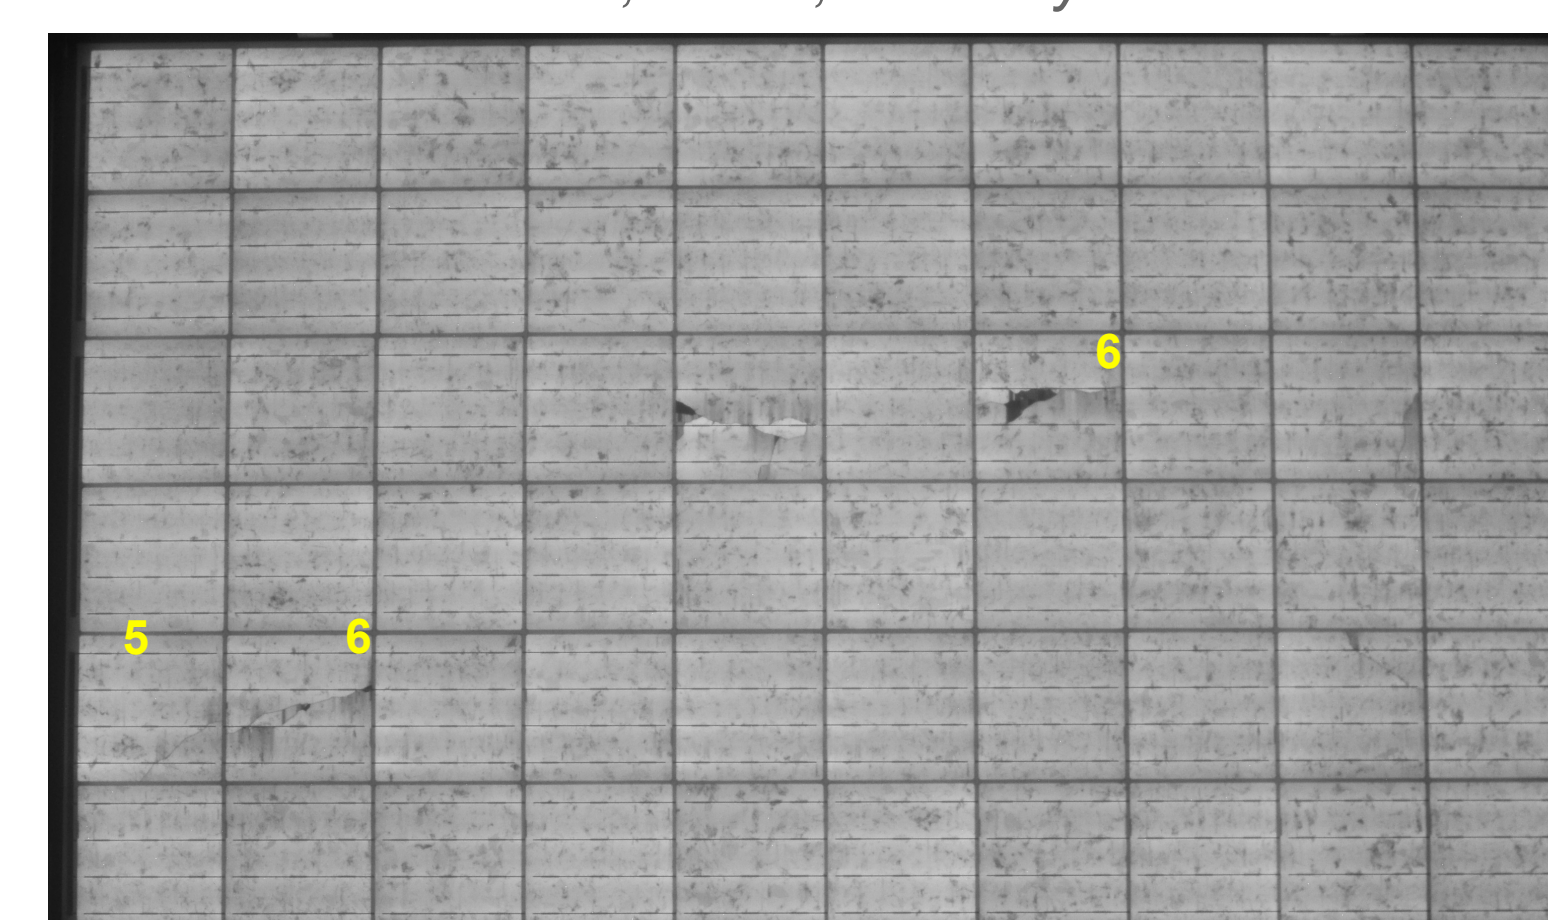
Figure 4. EL image at 0Pa after 31,000 cycles. Crack after 26000⁵, solder joint failure after 30000⁶ cycles.

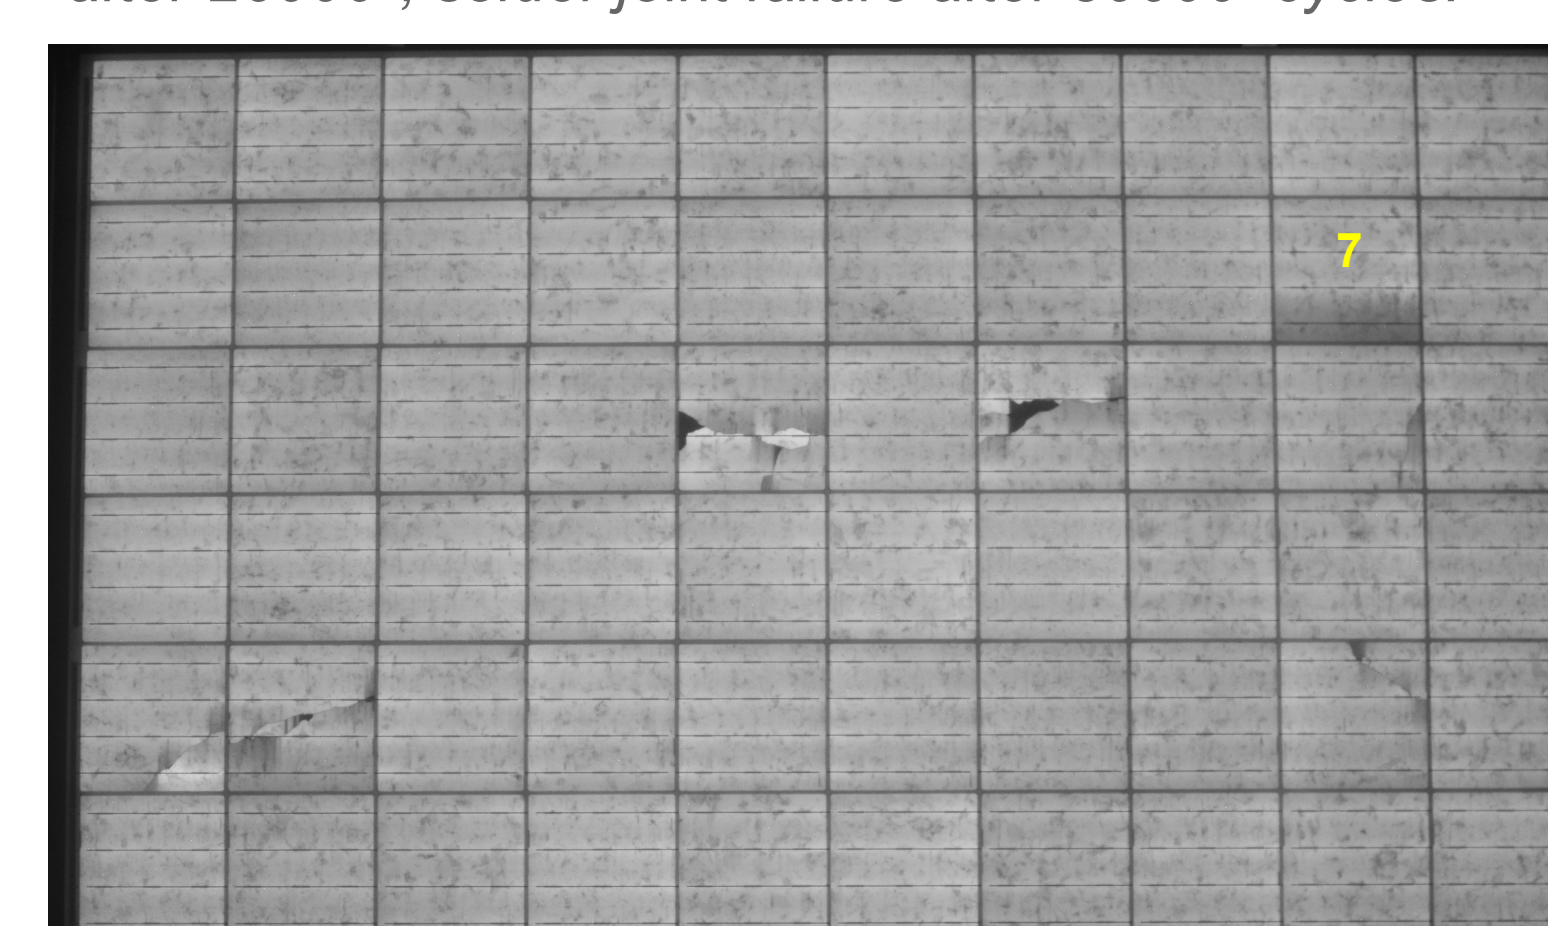
Figure 5. EL image at 0Pa after 50,000 cycles. Interconnect failure occurred after 45,000⁷ cycles.
