Task 13 Performance, Operation and Reliability of Photovoltaic Systems

Quantification of Technical Risks in PV Power Systems

Report IEA-PVPS T13-23:2021
October 2021

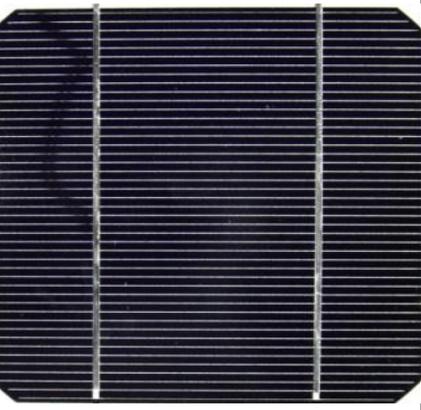
EXAMPLES (page1)		PVFS 1-1vs.01	
Examples 1-3

Cell chipping. A very small region is missing from the edge of the cell, but does not enter metalized region. [16]	Large crack at cell corner visible by eye - small portion of the cell (<10%) is no longer electrically connected. [16]	Cell crack with snail track. No isolation of any cell part. The propagation could isolate a cell area >10%. [16]
Severity

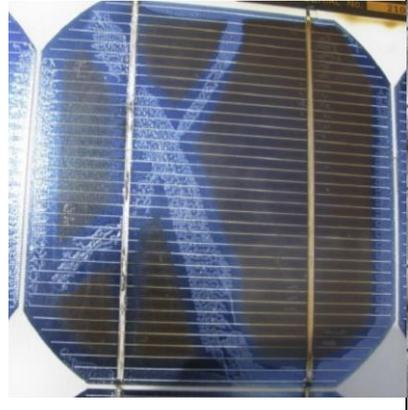
Examples 4-6

Cell cracks visible by the photo-bleaching effect. This may not be mistaken for snail tracks. [16]	Two cell cracks with extensive delamination, EVA browning and photo bleaching. [41]	EL image of 2 cell cracks which isolates more than 10% of the cell area. [TUV Rheinland]
Severity

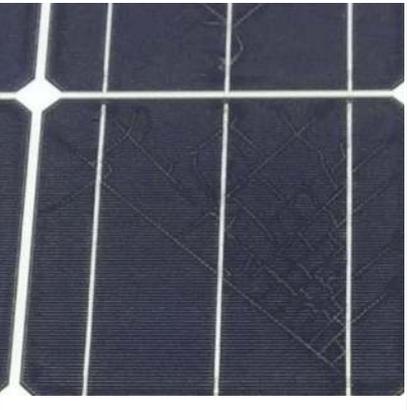
Examples 7-9

Snail track example. [41]	Snail track example. [41]	EL of cell cracks with snail tracks. [16]

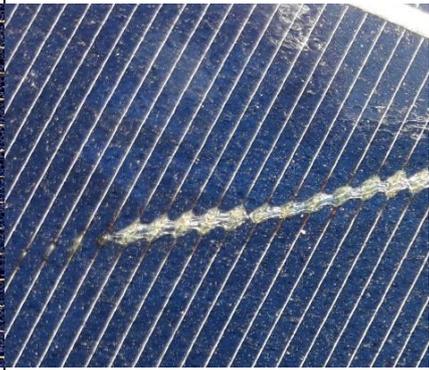
EXAMPLES (page2)		PVFS 1-1vs.01	
Examples 10-12

Zoom of snail track with delamination. [41]	Zoom of snail track with browned fingers. [37]	Zoom of snail track with delamination. [SUPSI]
Severity

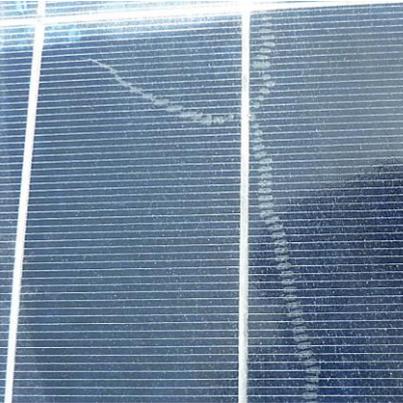
Examples 13-15

Cell crack with EVA delamination. [TUV Rheinland] (see also PVFS 1-3)	Typical EL picture of a cell crack caused by hail. [TUV Rheinland]	Repetitive crack pattern due to impact of soldering machine. [SUPSI]
Severity

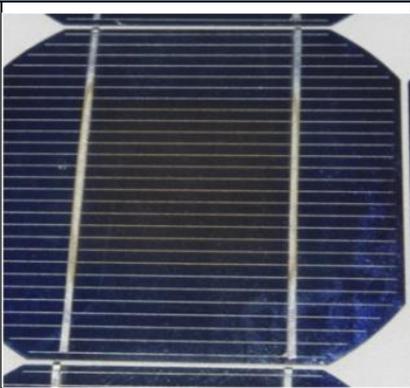
<p>Examples 1-3</p>

<p>Slightly browned EVA in the centre of the cell with photobleaching at the edges. [16]</p>	<p>Slightly browned EVA in the centre of the cell with photobleaching at the edges. [44]</p>	<p>Yellowed backsheet from the inside. [37]</p>			
<p>Severity</p>

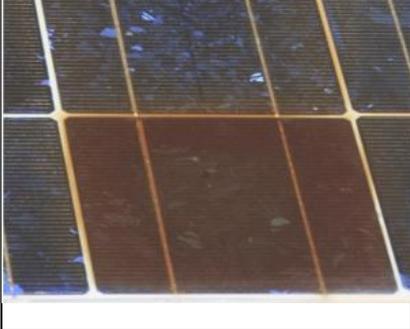
<p>Examples 7</p>

<p>Single cell browned much faster than the others due to local heating. [16]</p>					
<p>Severity</p>

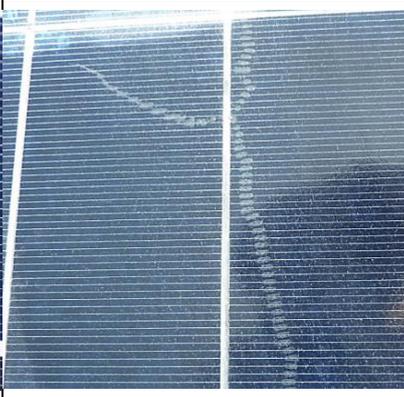
<p>Examples 4-6</p>

<p>Encapsulant delamination from glass (spotted due to glass texture) along the bus bars. [37]</p>	<p>Encapsulant delamination along a cell crack. [46] (see also PVFS 1-1)</p>	<p>Encapsulant delamination near cell edges in combination with cell browning. [38]</p>	
<p>Severity</p>

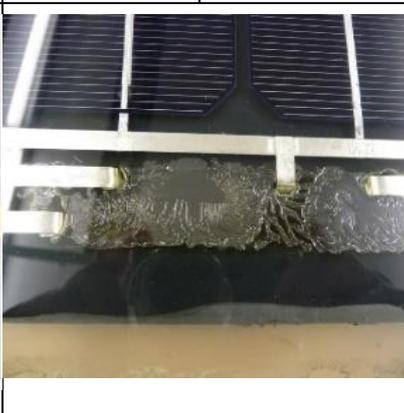
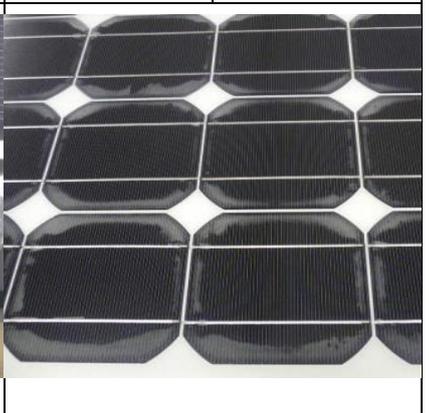
<p>Examples 7-9</p>

<p>Delamination in front of cell in the centre of the module. [40] (see also FS 1-2)</p>	<p>Delamination at module insert connections of a glass/glass module (junction box). [SUPSI]</p>	<p>Delamination at cell edges. [16]</p>	
<p>Severity</p>

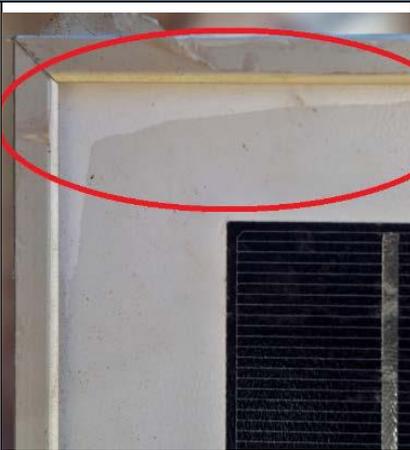
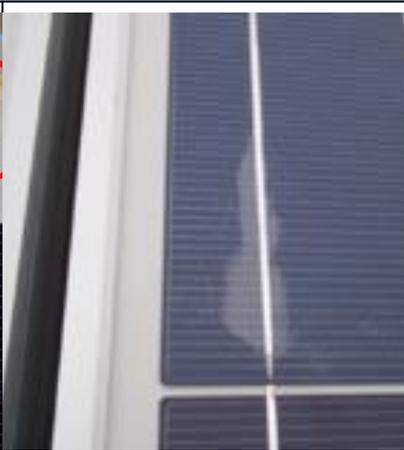
<p>Examples 10-12</p>

<p>Encapsulant delamination at borders. [37]</p>	<p>Encapsulant delamination along a bus-bar in a cell close to the module edge. [40]</p>	<p>Encapsulant delamination of from glass (spotted due to glass texture) at the edge of the cell. [37]</p>
<p>Severity</p>			
<p>Examples 13-15</p>

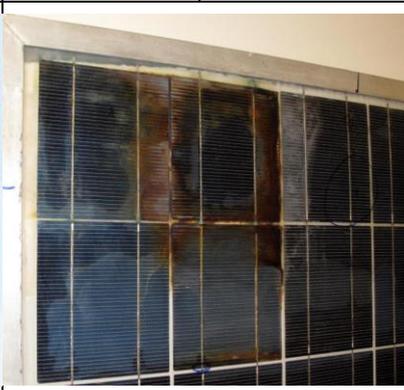
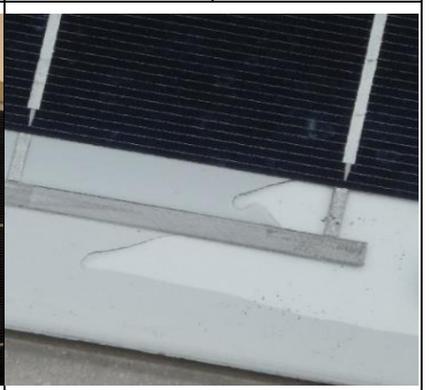
<p>Delamination creating a continuous path between electric circuit and the edge. [40]</p>	<p>Delamination with corrosion. [1] (see also FS1-11)</p>	<p>Delamination caused by detachment of backsheet with exposure of encapsulant from the back. [SUPSI]</p>
<p>Severity</p>

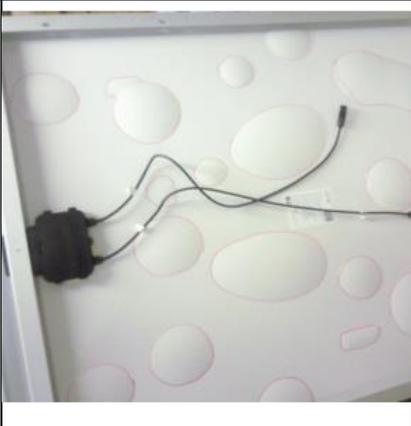
<p>Examples 1-3</p>

<p>Multiple bubbles in the centre and edge of the backsheet. [46]</p>	<p>Blisters because of vapour barrier, such as aluminium foil. [1]</p>	<p>Big central bubble + wavy delamination. [16]</p>
<p>Severity</p>

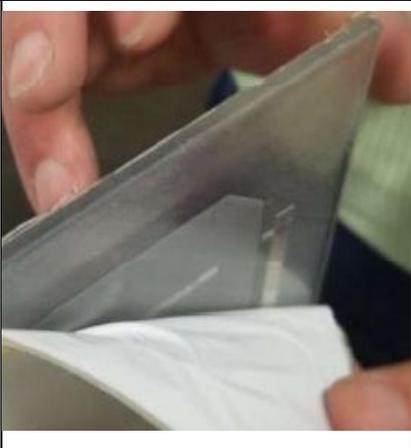
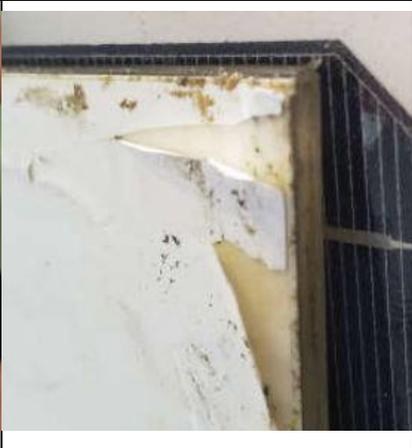
<p>Examples 4-5</p>

<p>Backsheet delamination with direct exposure of encapsulant. [SUPSI]</p>	<p>Delamination of top layer without exposure of encapsulant. [SUPSI]</p>	
<p>Severity</p>

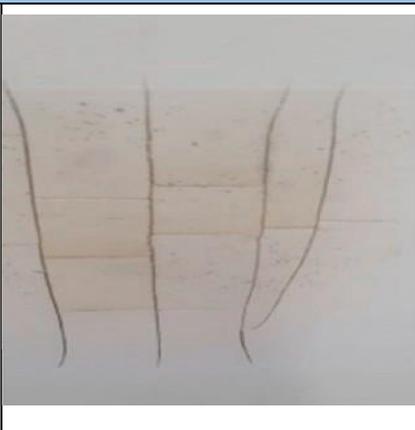
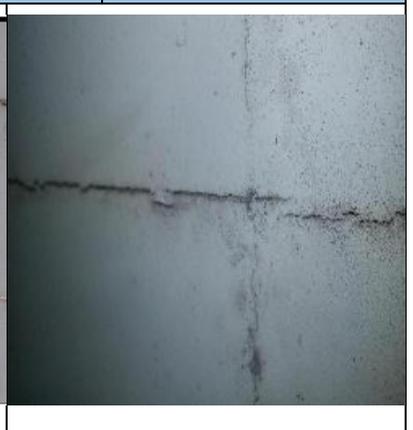
<p>Examples 1-3</p>

<p>Cracked backsheet in combination with yellowing under a hot cell. [39]</p>	<p>Squared cracks beneath cell interspaces. [39]</p>	<p>Cracking between cells. [38]</p>			
<p>Severity</p>

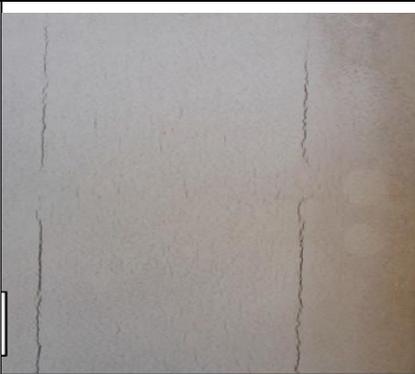
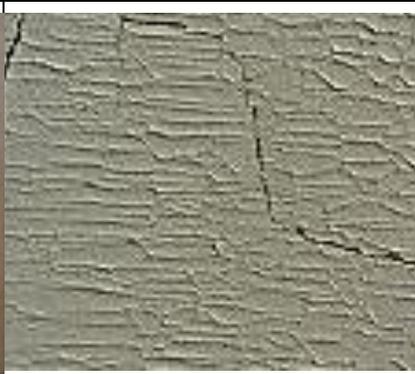
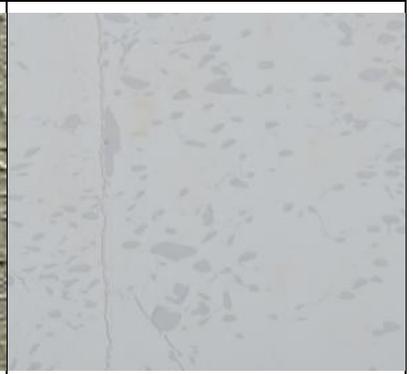
<p>Examples 4-6</p>

<p>Longitudinal cracks located under bus bars. [39]</p>	<p>Backsheet cracking. [57]</p>	<p>Backsheet cracking. [57]</p>			
<p>Severity</p>

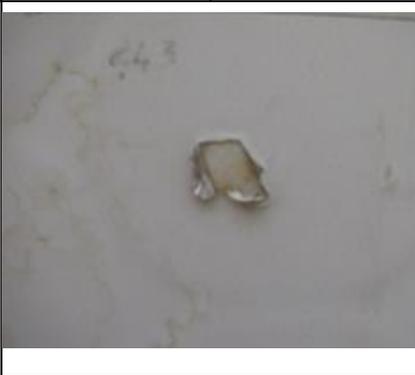
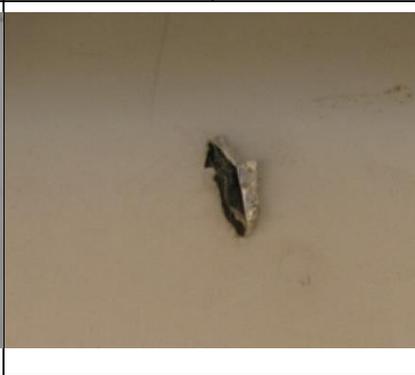
<p>Examples 7-8</p>

<p>Localized superficial damage. [1]</p>	<p>Deep scratch on backsheet. [TUV Rheinland]</p>				
<p>Severity</p>

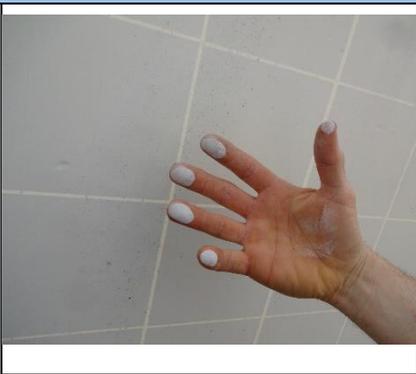
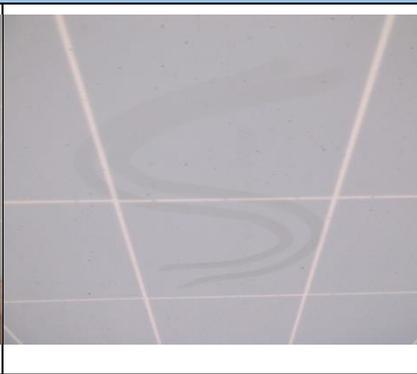
<p>Examples 1-2</p>

<p>Finger with white powder. [TUV Rheinland]</p>	<p>Fingerprint on a module with chalking. [TUV Rheinland]</p>				
<p>Severity</p>

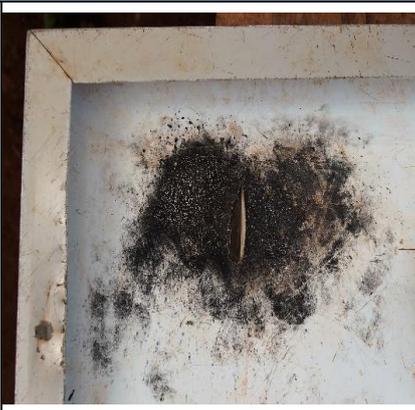
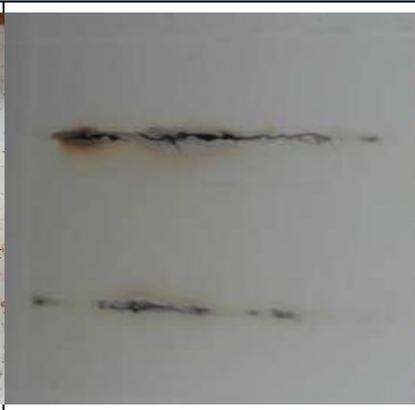
<p>Examples 1-3</p>

<p>Burn mark at the backsheet with cracked backsheet. [37]</p>	<p>Burn marks at the backsheet due to heating along a busbar. [16]</p>	<p>Burn mark associated with overheating along the metallic interconnection (without backsheet damage). [16]</p>
<p>Severity</p>

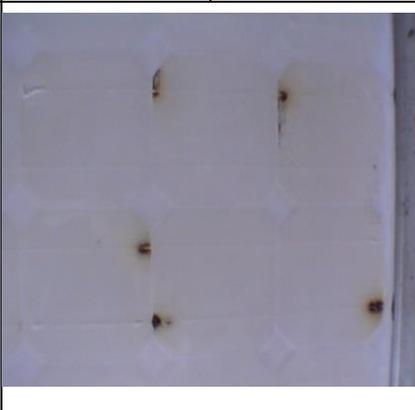
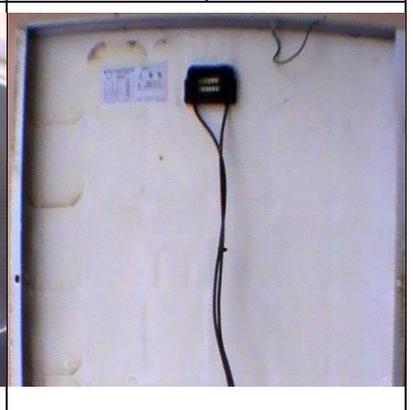
<p>Examples 4-6</p>

<p>Front and back side view of burn marks caused by open-circuited bypass diodes and current mismatch conditions (due to shading or cracked cells). [16]</p>		<p>Burn marks caused by defect bypass diodes or an interconnect failure in the junction box. [16]</p>
<p>Severity</p>

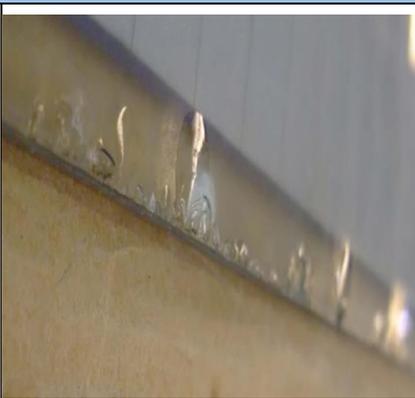
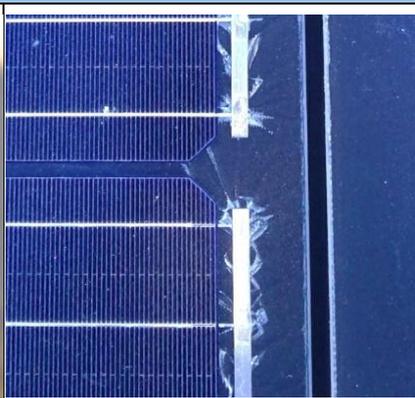
<p>Examples 1-3</p>

<p>Chipped glass at the corner. [38]</p>	<p>Glass breakage along the string interconnect ribbons due to weak manufacturing process. [SUPSI]</p>	<p>Glass breakage of tempered glass induced by a hot-spot. [SUPSI]</p>
<p>Severity</p>

Component Defect	Module	PVFS 1-8vs.01	
Appearance	Glass is cracked locally or over the full area of the module. Glass breakage looks different depending on the type of glass and the origin of the glass breakage. Tempered glass or heat-treated float glass will shatter into small pieces, whereas annealed glass breaks into big pieces. Heat-treated glass stays in between.		
Detection	VI, IRT		
Origin	Glass breakages of the front glass can be caused by heavy impacts such as hail or stones or other extreme mechanical stress onto the module frame due to external stresses or bad mounting. High temperatures (hot-spot or arc) can also break the glass. Annealed glass breaks also due thermal gradients or stress induced by the lamination process or cleaning of the modules. A relatively often seen failure in the field is glass breakage of frameless PV modules caused by the clamps. Glass/glass modules are more sensitive to glass breakage. The origin of the failure is, on the one hand, at the planning and installation stage either (a) poor clamp geometry for the module, e.g. sharp edges, (b) too short and too narrow clamps or (c) the positions, kind or number of the clamps on the module not being chosen in accordance with the manufacturer's manual. The second origin which induces glass breakage could be excessively-tightened screws during the mounting phase or badly-positioned clamps. The glass of some PV modules may also break due to vibrations and shocks occurring during transportation or handling. Another reason for glass breakage comes from impact stresses on the glass edge. Sometimes vandalism or animal damage happens, the animals like goats like to climb on the PV modules, and birds may drop stone or other objects from the sky.

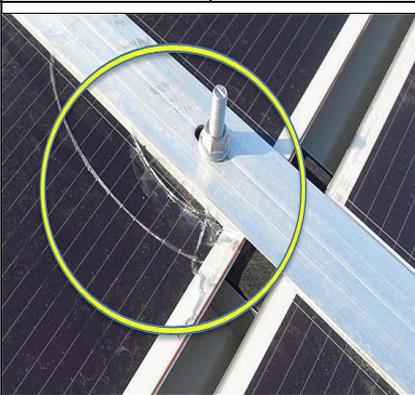
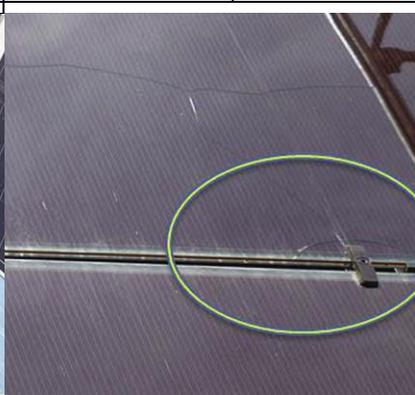
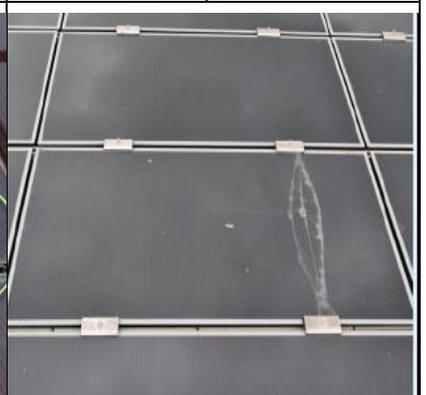
<p>Examples 4-6</p>

<p>Glass breakage caused by too tight screws. [16] (see also PVFS 3-1)</p>	<p>Glass breakage caused due to poor clamp design. [16]</p>	<p>Glass breakage caused due to poor clamp design. [1] (see also PVFS 3-1)</p>
<p>Severity</p>

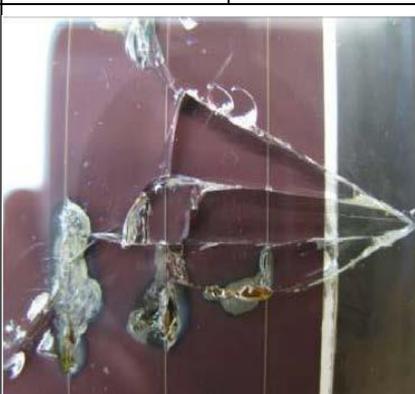
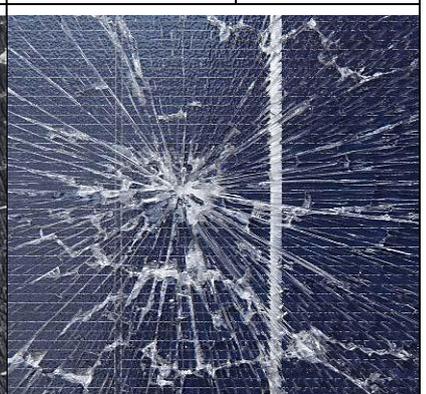
<p>Examples 7-9</p>

<p>Glass breakage through high temperature gradient and not tempered glass. [16]</p>	<p>Glass breakage of tempered glass induced by burn mark. [1] (see also PVFS 1-7 and PVFS 1-9)</p>	<p>Breakage of tempered glass. [1]</p>
<p>Severity</p>

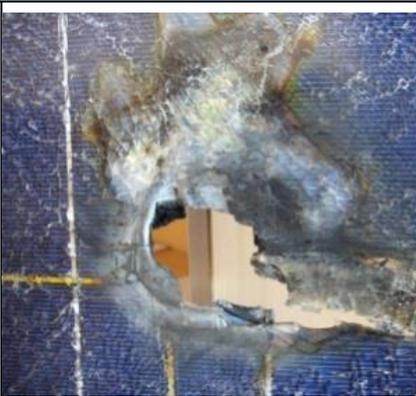
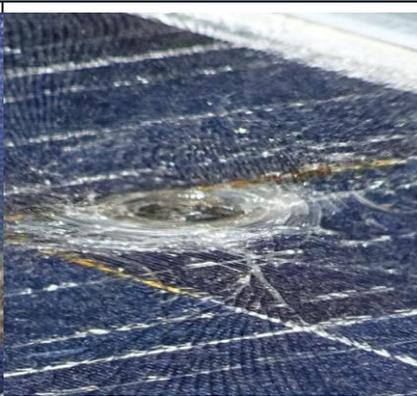
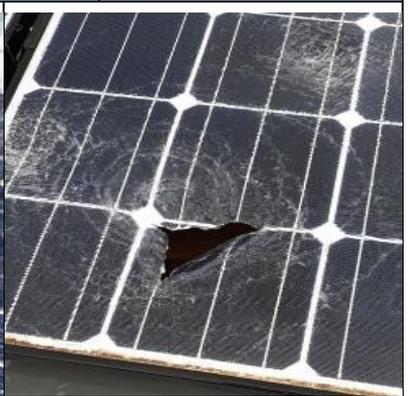
<p>Examples 10-12</p>

<p>Direct lightning stroke. [46]</p>	<p>Impact damage caused by a heavy object. [SUPSI]</p>	<p>Hail damage. [SUPSI]</p>			
<p>Severity</p>

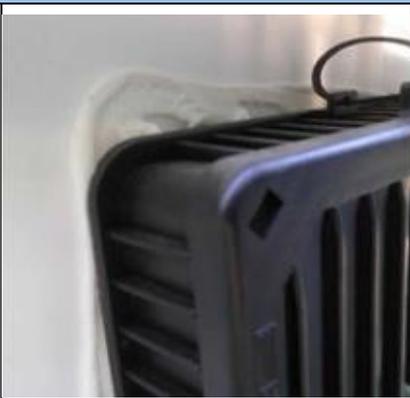
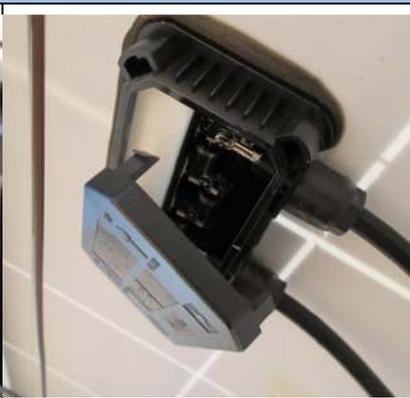
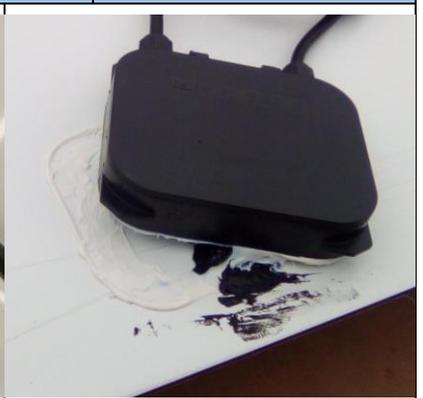
<p>Examples 1-3</p>

<p>Poorly bonded junction box on the backsheet. [16]</p>	<p>Open junction box in the field. [41]</p>	<p>Detached junction box from backsheet. [SUPSI]</p>
<p>Severity</p>

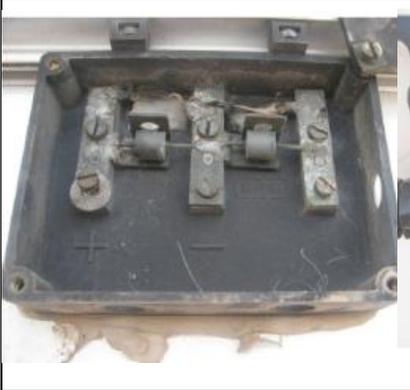
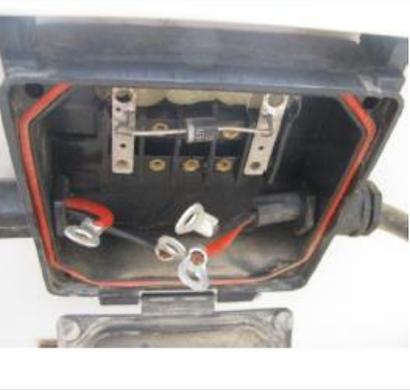
<p>Examples 4-5</p>

<p>Left: Missing junction box lid sealing with corrosion of contacts. Right: Good junction box sealing. [45]</p>		<p>Missing seal or strain relive of module cables, improper cable inlet. [37]</p>
<p>Severity</p>

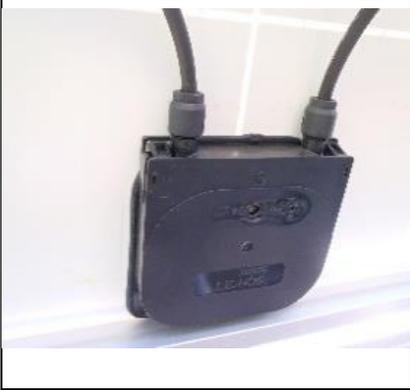
<p>Examples 6-7</p>

<p>Melted junction box. [TUV Rheinland]</p>	<p>Burned junction box caused by corroded contacts within the junction box. [TUV Rheinland]</p>	
<p>Severity</p>

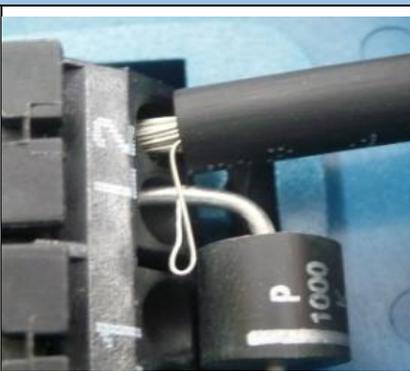
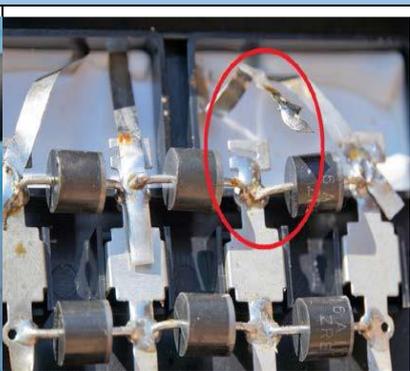
<p>Examples 1-3</p>

<p>Junction box with poor wiring. [16]</p>	<p>Detached tabbing ribbon due to bad soldering. [16]</p>	<p>Corrosion failure due to water soaking of the IP65 rated Jbox. [41]</p>
<p>Severity</p>			
<p>Examples 4-6</p>

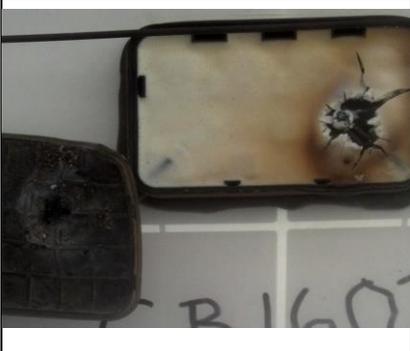
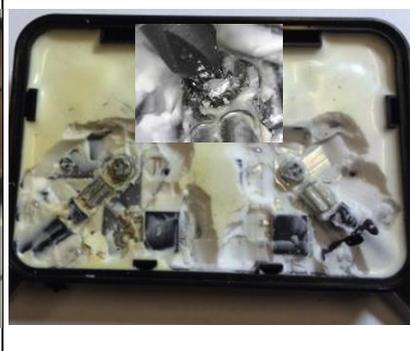
<p>Jbox failure due to poor electric connection. [41]</p>	<p>Evidence of loose screw connection inside Jbox with browning of pottant. [41]</p>	<p>Cold soldering of module busing ribbon to the Jbox connection terminal pad with minor browning of pottant. [41]</p>
<p>Severity</p>			
<p>Examples 7-9</p>

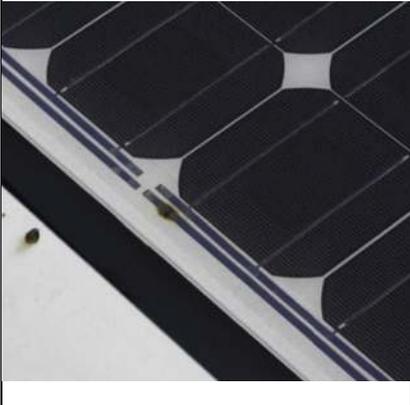
<p>Overheating due to the poor Jbox interconnect leading to light discoloration and burn mark on front and back side. [41]</p>	<p>Overheating due to the poor Jbox interconnect leading to burn mark and glass breakage. [41]</p>	<p>IR imaging of a hotspot Jbox due to loose electric connection inside. [41]</p>
<p>Severity</p>

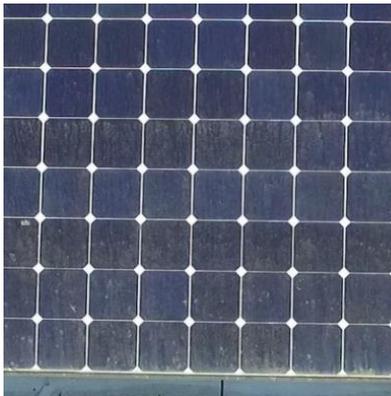
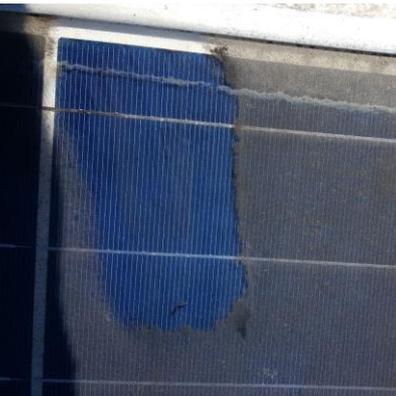
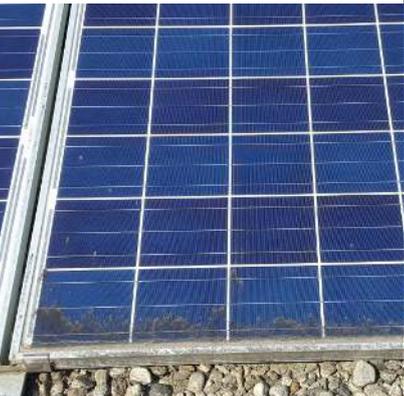
<p>Examples 1-3</p>

<p>Uniform light soiling, which in ideal conditions is self-cleaning when raining.</p>	<p>Uniform heavy soiling caused by rail way station. [SUPSI]</p>	<p>Non-uniform soiling caused by low inclination and close mounting to roof. [SUPSI]</p>
<p>Severity</p>

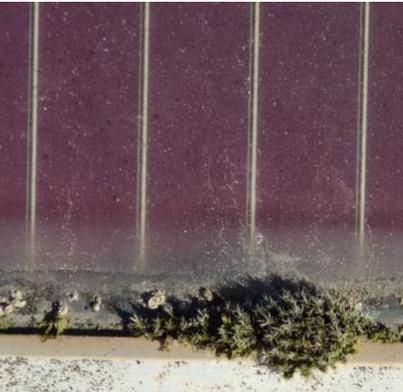
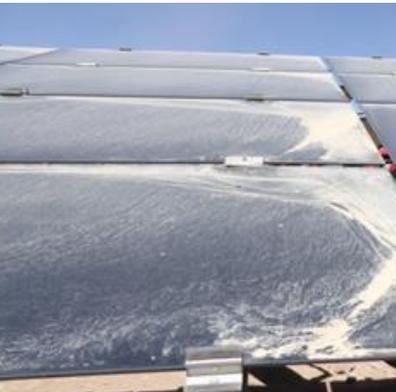
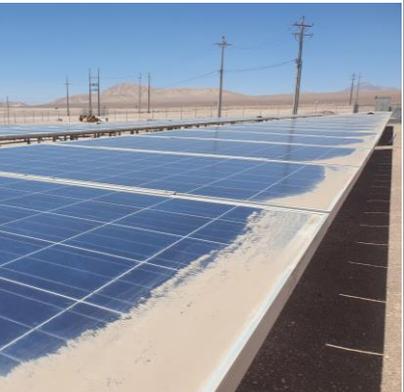
<p>Examples 4-6</p>

<p>Moss growing on the edge of a module combined with edge soiling. [1]</p>	<p>Soiling pattern on a system in the Atacama desert. [ISE]</p>	<p>Soiling pattern demonstrating dominant wind direction on a test site in Atacama desert. [ISE]</p>
<p>Severity</p>

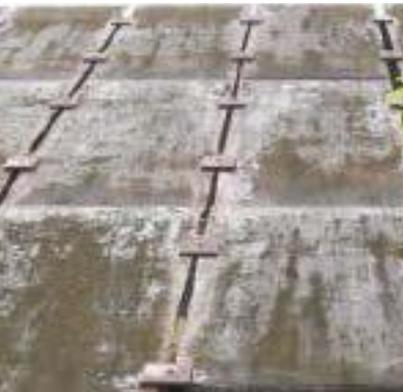
<p>Examples 7</p>

<p>Heavy biofilm soiling. [46]</p>		
<p>Severity</p>

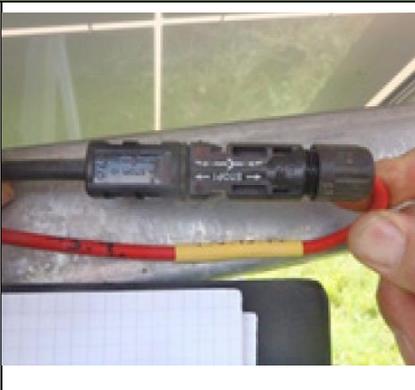
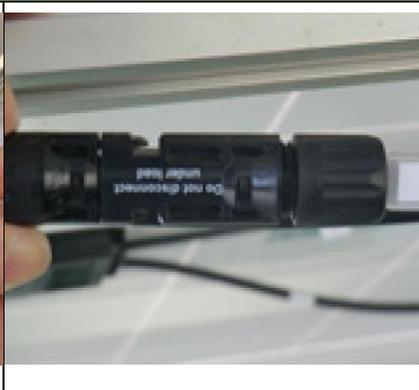
<p>Examples 1-2</p>

<p>Connectors (male of female) are of different brand or type and obviously do not match. [40]</p>	<p>Connectors (male of female) are of different brand or type and obviously do not match. [40]</p>				
<p>Severity</p>

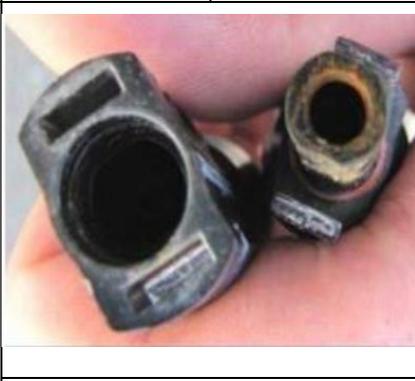
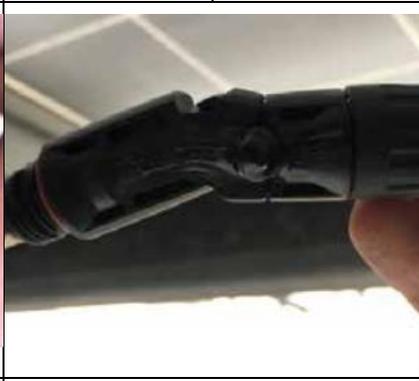
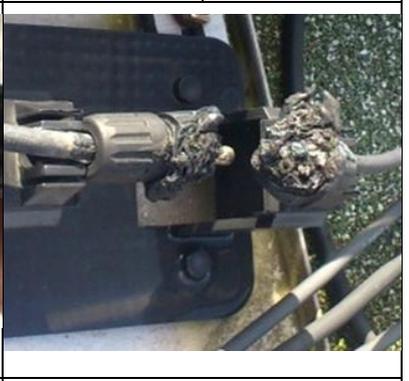
<p>Examples 3-5</p>

<p>Corroded connector due to cross-mating. [Stäubli]</p>	<p>Melted connector due to cross-mating. [Stäubli]</p>	<p>Burned connector due to cross-mating. [Stäubli]</p>			
<p>Severity</p>

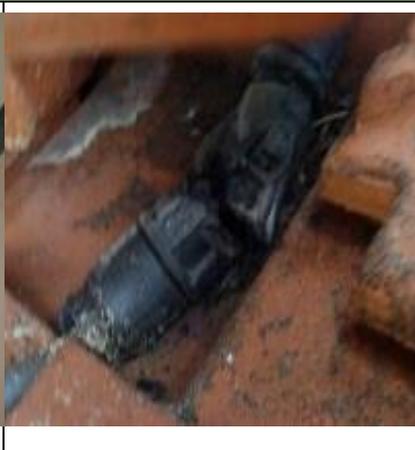
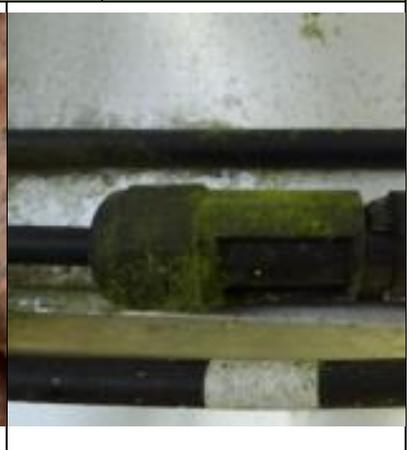
<p>Examples 1-3</p>

<p>Burned connector. [1]</p>	<p>Corroded Cable. [1]</p>	<p>Animal bite on cable. [1]</p>			
<p>Severity</p>

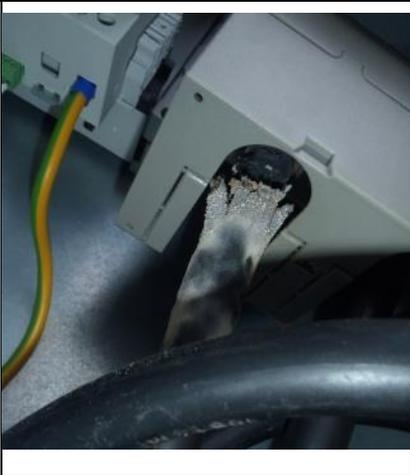
<p>Examples 4</p>

<p>Connecting terminals show signs of burning, have melted or charred. [TUV Rheinland]</p>

Component	Cables and Interconnectors		FS 2-4vs.01
Defect	Thermal damage in combiner box		
Appearance	Defects appearing in the combiner box as discoloured or burned cable interconnections or fuses. Damaged parts can be found by visual inspection or infrared thermography (IRT).		
Detection	VI, IRT, (MON)		
Origin	Thermal damages in the combiner box can be due to the selection of inadequate components (e.g underrated fuses or fuse holders), a not proper connection of DC cables (e.g improper wire torqueing, missing fuses) or a wrong wiring of the modules/strings in the field or on-roof.		
	Production <input type="checkbox"/>	Installation <input type="checkbox"/>	Operation <input type="checkbox"/>
Impact	This damage is caused by the excess heat generated in fuse holder and defect DC connectors/cables . The partial or complete thermal damage of the combiner box leads to performance losses, electrical shock hazards and risk of fire. Actions must be taken immediately by qualified personnel to prevent further damage.

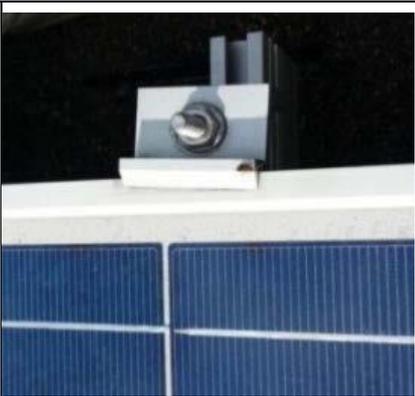
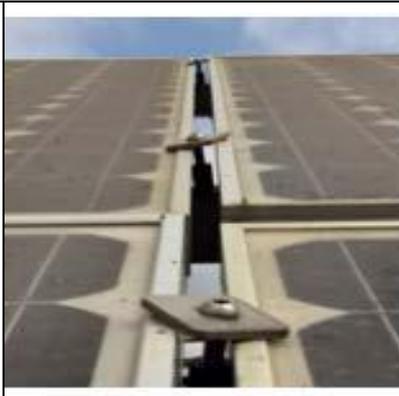
<p>Examples 1-3</p>

<p>Improper installation of clamp. [?]</p>	<p>Wrong combination of clamps and modules. [40]</p>	<p>Glass breakage caused by too tight screws. [35] (see also PVFS 1-8)</p>			
<p>Severity</p>

Component	Mounting		PVFS 3-1vs.01
Defect	Bad module clamping		
Appearance	Inadequate fastening or damage of the module or frame by the clamp.		
Detection	VI		
Origin	The installation instructions of the module and mounting structure from the manufacturer are not followed. Typical errors at the planning and installation stage are: (a) use of inadequate clamps for the selected module and/or mounting structure, e.g. sharp edges damaging glass/glass modules, wrong combination of clamps and modules or mounting structure (b) too short and too narrow clamps or (c) the positions, kind or number of the clamps on the module not being chosen in accordance with the manufacturer's manual. Other errors are too excessively or insufficiently tightened screws during the mounting phase.		
	Production	Installation	Operation
Impact	An improperly installed clamp compromises the integrity of the mounting system and the ability of the module to stay in place under high wind or load conditions. The detachment of modules can happen as series effect because the modules share the clamps with the module next to it. Once one module is detached, the clamp immediately loses fixing force on the next module and result in series detachment. The detachment of the module/s from the mounting structure is posing a serious hazard to persons and the risk of damaging the rest of the system and/or the property in the vicinity of the installation site. Problems such as frame damage, glass breakage or cell cracks can occur compromising on the long term the performance and the electrical safety.

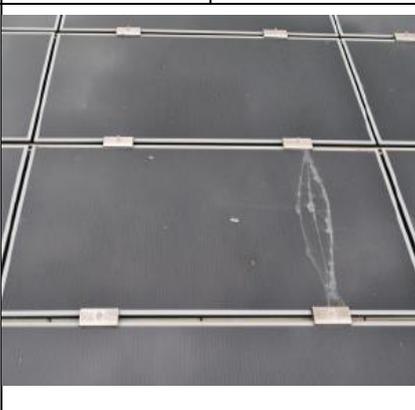
<p>Examples 4</p>

<p>Glass breakage caused by poor clamp design. [40] (see also PVFS 1-8)</p>					
<p>Severity</p>

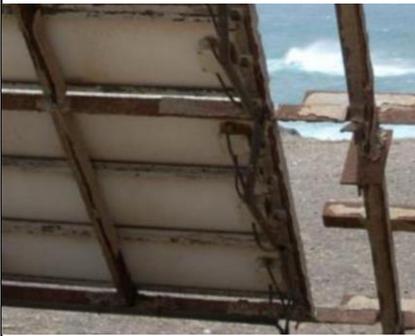
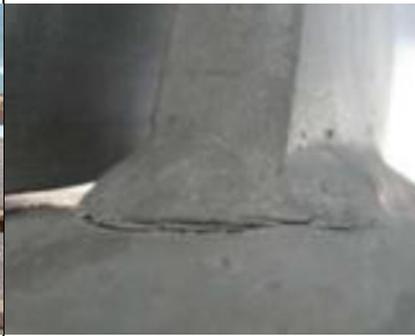
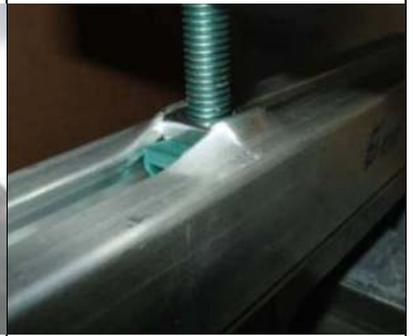
<p>Examples 1-3</p>

<p>Corrosion due to salt water. [46]</p>	<p>Cracks in mounting structure due to mechanical stress. [46]</p>	<p>Screw canal bends due to mechanical stress. [46]</p>			
<p>Severity</p>

Component	Mounting		PVFS 3-2vs.01
Defect	Inappropriate/defect mounting structure		
Appearance	Mechanical damages (e.g cracking, bending) or other visual defects (e.g. corrosion of frame or mounting holes) observable on the mounting structure.		
Detection	VI		
Origin	Typically, this failure occurs when the mounting structure is not designed to withstand the wind or snow loads which are typical for the site in which the system is installed (e.g. mounting structure does not comply with static calculations, underestimation of the environmental conditions), or if the anchorage of the mounting structure to the ground or roof is weak (e.g. ground conditions are not considered sufficiently when choosing the mounting structure). The roof strength, to withstand the added load of the PV system and include allowance for O&M activities, is not verified. Another reason for the failure of a mounting structure is the use of inappropriate materials (e.g use of corrosive materials in a corrosive environment, insufficient galvanisation, poor quality material due to a bad or missing quality assurance in production), leading to a premature degradation or mechanical failure of the mounting structure. Installation errors (e.g. missing/non-original components, excessively or insufficiently tightened screws) can be the origin of a failure of the mounting structure.

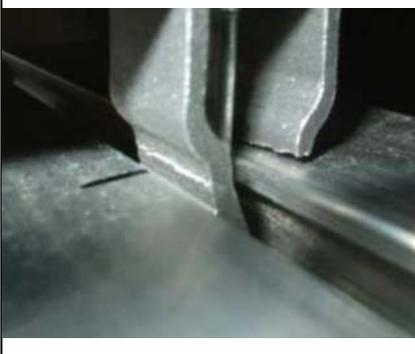
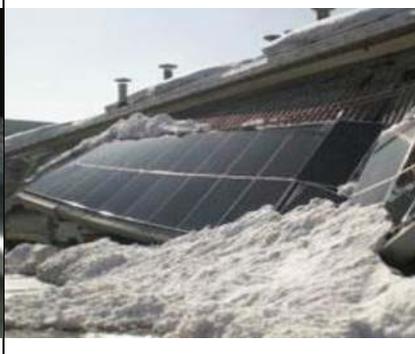
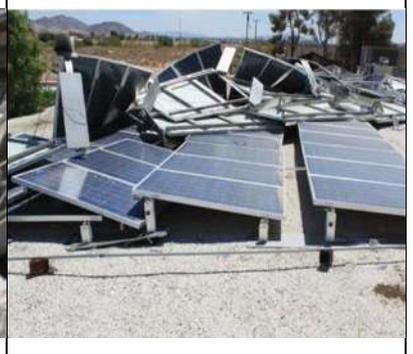
<p>Examples 4-6</p>

<p>Bracket fractured due to mechanical stress. [46]</p>	<p>Undersized mounting structure for local snow load conditions. [46]</p>	<p>Undersized mounting structure for local wind conditions. [15]</p>			
<p>Severity</p>

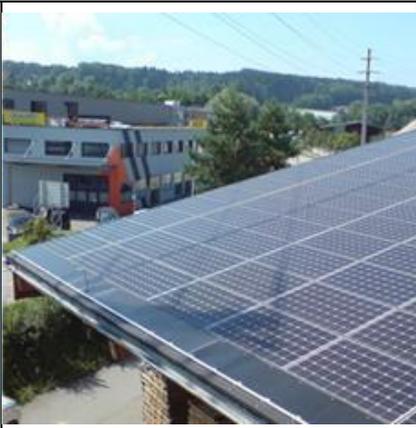
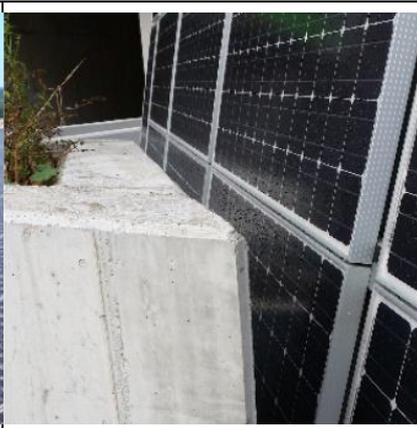
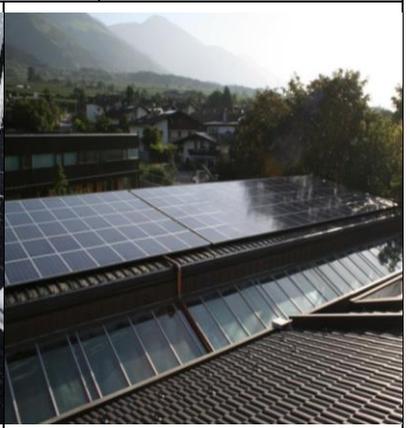
<p>Examples 1-3</p>

<p>Shading by pole-and-wire (poor design: too close to nearby shading objects). [36]</p>	<p>Shading due to bad planning or coverage by afterwards build construction element. [40]</p>	<p>Shading by tree with seasonal changes due to foliage. [40]</p>			
<p>Severity</p>

Component Defect	Mounting Module shading		PVFS 3-3vs.01
Appearance	Depending on the position of the sun (day and time), shading can be seen either by eye when performing a visual inspection, or by comparing monitoring data of unshaded and shaded strings or by running shading simulations. The shade can have different patterns and change/move over the day and season.		
Detection	VI, (MON, IRT)		
Origin	The choice of the mounting structure and the position in which the modules are mounted influences the shading conditions. Shading can be caused by different factors or obstacles e.g trees, antennas, poles, chimneys, satellite dishes, roof or façade protrusions, near buildings, cables, or by self-shading (inter array or row-to-row shading) or soiling. Shading conditions can change over the lifetime of a PV system due to growing vegetation, new constructions or construction elements. It can be distinguished between different types of shades: direct shades hindering the direct light to reach the module or diffuse shades.

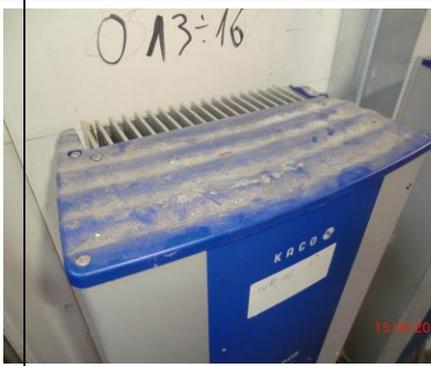
Examples
1-3

Dust blocking heat dissipation [TUV Rheinland]

Component Defect	Inverter Overheating			PVFS 4-1vs.01
Appearance	The inverter reduces its power or switches off to protect components from overheating (temperature derating). Inverters do not always deliver a corresponding status message "power reduction" or "derating". For this reason, it is recommended to check the inverter behaviour by determining and analysing performance curves (Power vs Irradiance).			
Detection	MON, (IV, IRT)			
Origin	Temperature derating of the inverter can occur for various reasons, e.g. improper installation of the inverter, fan failure, dust blocking heat dissipation or an incorrect programming of the inverters.			
	Production <input type="checkbox"/>	Installation <input type="checkbox"/>	Operation <input type="checkbox"/>	
Impact	When the monitored components in the inverter reach the maximum operating temperature, the inverter shifts its operating point to a lower power. During this process, power is reduced step-by-step. In the extreme case, the inverter switches off completely. As soon as the temperature of the threatened components falls below the critical value, the inverter returns to the optimal operating point. The partial or complete failure of the inverter leads to performance losses, which will get worse if the problem is not solved. In the worst case inverter will switch off. Inverter overheating does not affect module safety.

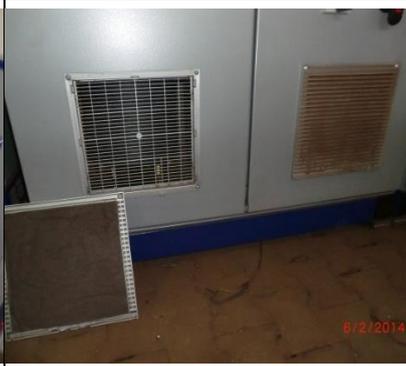
A soiled air filter causes overheating [TUV Rheinland]

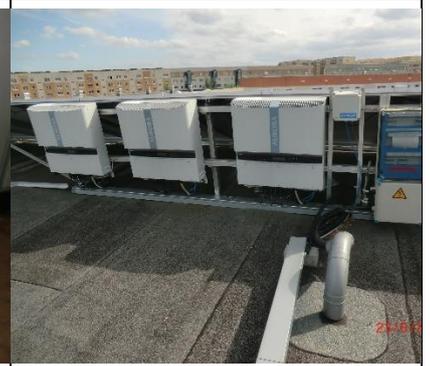
Installation not appropriate (direct exposition to sun) [TUV Rheinland]

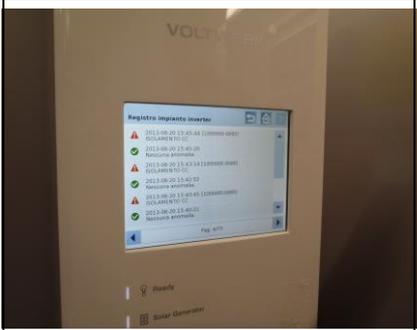
Examples
1-3

Insulation failure. [TUV Rheinland]

Component	Inverter			PVFS 4-3vs.01
Defect	Not operating (complete failure)			
Appearance	If the inverter does not work despite good production conditions, common problems are the lack of restart after grid faults or isolation faults . The inverter may show fault codes to help understanding the problem. This can be observed by checking the display or the data log of the monitoring system. Examples for hardware defects in the inverter are discoloured or burned cable interconnections or fuses. Damaged parts can be found by visual inspection or infrared thermography (IRT).			
Detection	MON, (VI, I-V, VOC)			
Origin	A complete failure of the inverter occurs due one or more malfunctions of single hardware or software component of the inverter or faults due to grounding issues, e.g. high humidity inside the inverter, or a firmware issue.			
	Production <input type="checkbox"/>	Installation <input type="checkbox"/>	Operation <input type="checkbox"/>

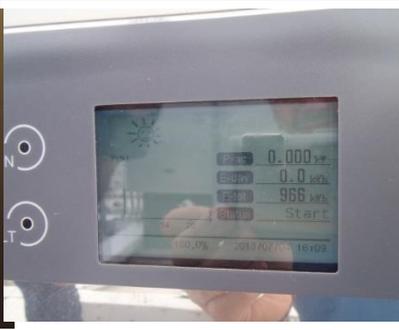
Not operating inverter. [TUV Rheinland]

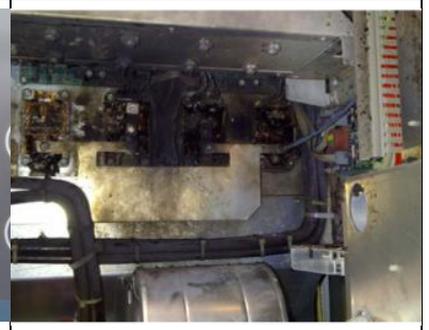
Damaged hardware component. [37]
