20125 Test Report: IAM and NMOT Testing of QCELLS Q.Peak-G4.1 300 Module

Report Number:	20125-PR-E-008			
Report Date:	2020-12-17			
Test Period:	2020-05-29 to 2020-12-10			
Project ID:	20125 (CFV), 2156362 (Customer PO)			
Customer:	Joshua Stein / Sandia National Laboratories / PO Box 5800 MS0951 / Albuquerque, NM 87185-0951			
Report Prenared by	Report Approved by:

CFV Labs conducted Nominal Module Operating Temperature (NMOT) and Incident Angle Modifier (IAM) testing file testing on one **Q.Peak-G4.1 300** module produced by **QCELLS**. NMOT testing was conducted in accordance with IEC 61853-2:2016. Incident angle modifier (IAM) testing was conducted using an outdoor method in accordance with IEC 61853-2:2016 and a method based on the Sandia procedure SAND2016-5284 was used.

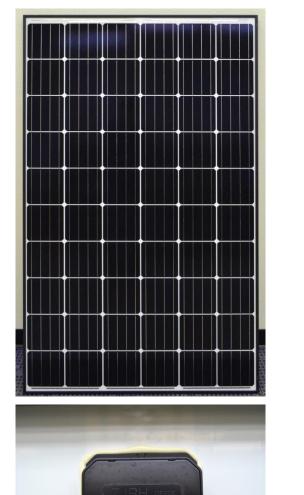
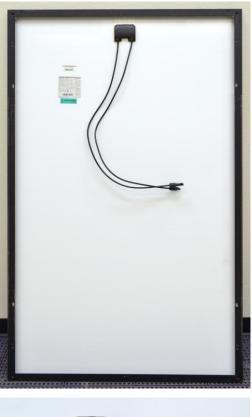
Photographs

QCELLS Q.Peak-G4.1 300

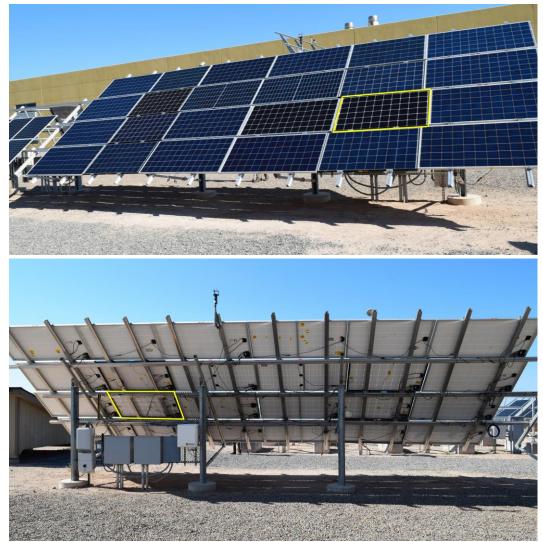
The test setup is shown in the images below. The test module is outlined in yellow. The pyranometer and windspeed sensor can be seen near the top of the test array. The ambient temperature sensor was mounted behind the test array.
