20125 Test Report: IAM and NMOT Testing of itek Energy IT-360-SE72 Module

Report Number: 20125-PR-E-009
Report Date: 2020-12-17
Test Period: 2020-05-29 to 2020-12-10
Project ID: 20125 (CFV), 2156362 (Customer PO)
Customer: Joshua Stein / Sandia National Laboratories / PO Box 5800 MS0951 / Albuquerque, NM 87185-0951

CFV Labs conducted Nominal Module Operating Temperature (NMOT) and Incident Angle Modifier (IAM) testing file testing on one **IT-360-SE72** module produced by **itek Energy**. NMOT testing was conducted in accordance with IEC 61853-2:2016 with modified data filtering requirements. Incident angle modifier (IAM) testing was conducted using an outdoor method in accordance with IEC 61853-2:2016 and a method based on the Sandia procedure SAND2016-5284 was used.

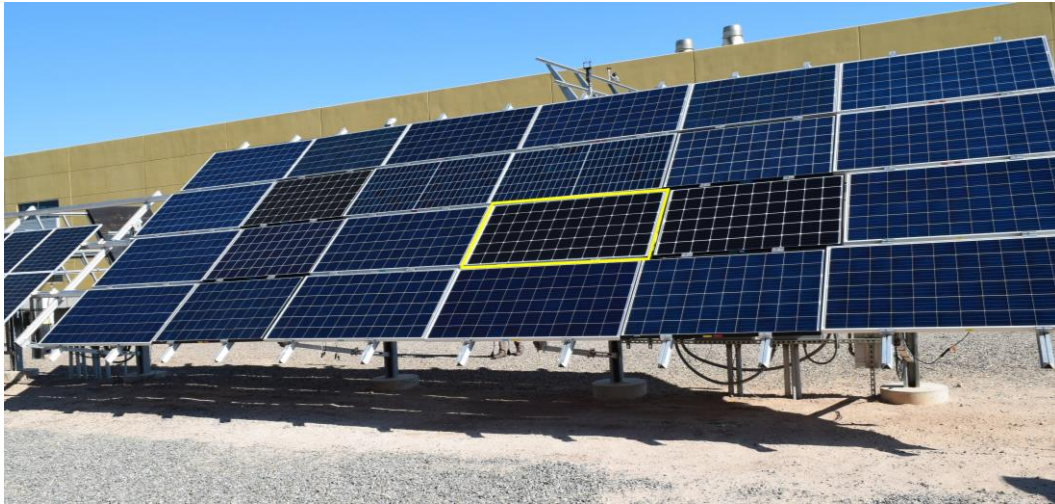
The test setup is shown in the images below. The test module is outlined in yellow. The pyranometer and windspeed sensor can be seen near the top of the test array. The ambient temperature sensor was mounted behind the test array.

The test module(s) were installed on our NMOT test stand as shown in the figures below.

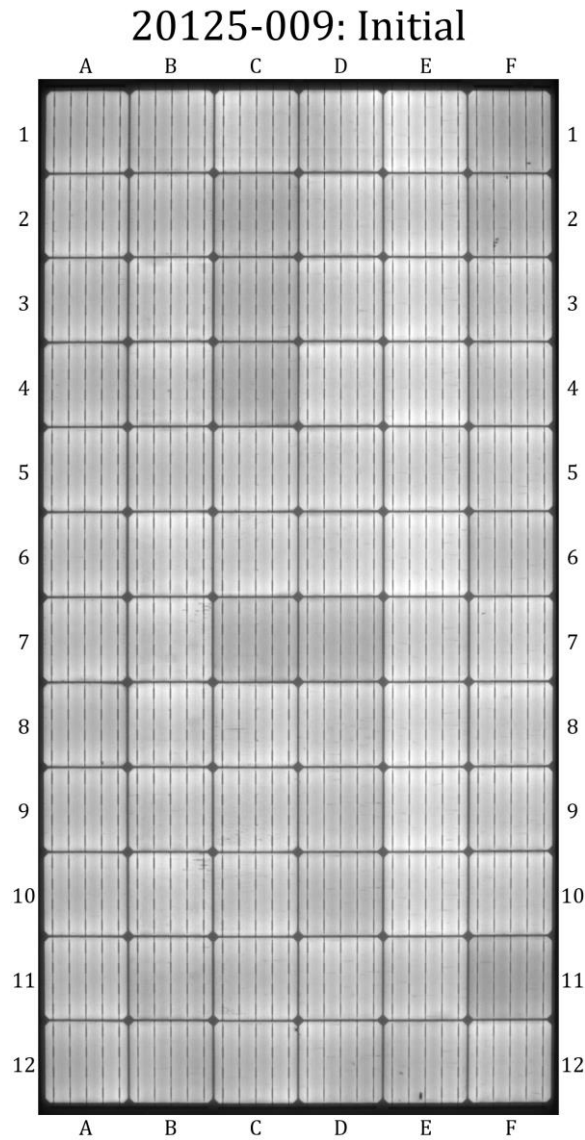
The module was imaged in the dark while a constant DC bias current ($1.0 \times I_{sc}$) was applied to the module. EL images of the test modules were originally taken as part of project 19074 and carried over for this report.

EL imaging was performed in conformity with IEC TS 60904-13:2018. CFV is ISO 17025-accredited to perform the test. EL images were taken with a Sensovation HR-830 camera that has a resolution of 8.3 MPixels. A long pass filter blocked incoming light with wavelength below 850 nm. A constant DC bias was applied to the modules while the imaging was performed in the dark.
