20125 Test Report: IAM and NMOT Testing of Panasonic VBHN325SA 16 Module

Report Number: 20125-PR-E-001
Report Date: 2020-12-17
Test Period: 2020-05-29 to 2020-12-10
Project ID: 20125 (CFV), 2156362 (Customer PO)
Customer: Joshua Stein / Sandia National Laboratories / PO Box 5800 MS0951 / Albuquerque, NM 87185-0951

CFV Labs conducted Nominal Module Operating Temperature (NMOT) and Incident Angle Modifier (IAM) testing file testing on one **VBHN325SA 16** module produced by **Panasonic**. NMOT testing was conducted in accordance with IEC 61853-2:2016. Incident angle modifier (IAM) testing was conducted using an outdoor method in accordance with IEC 61853-2:2016 and a method based on the Sandia procedure SAND2016-5284 was used.

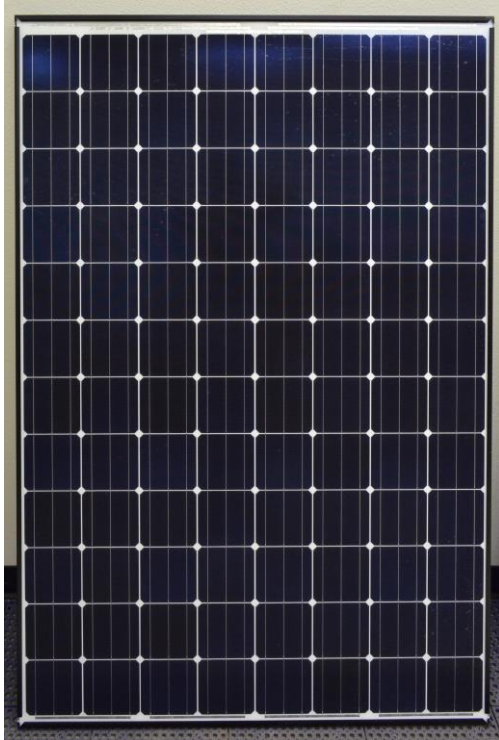
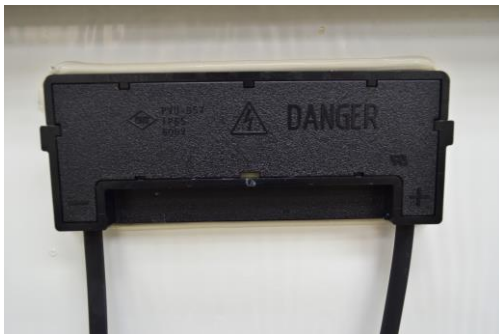
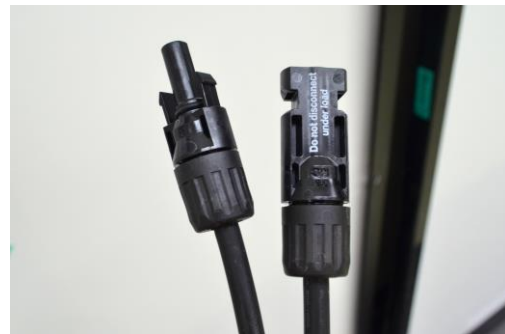
Panasonic VBHN325SA 16

Photographs

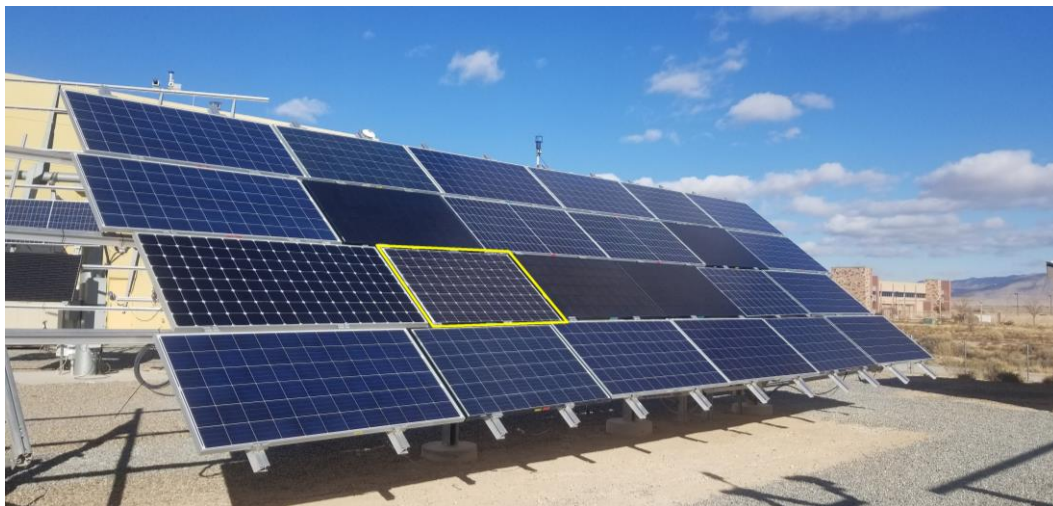
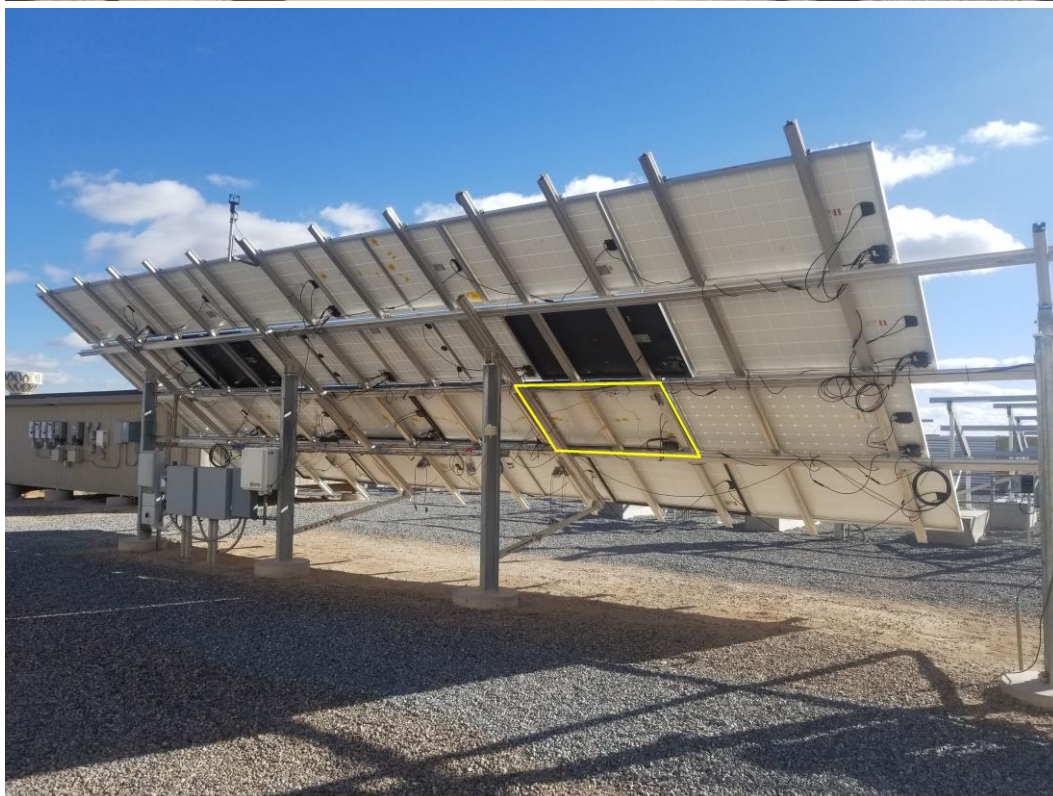
The test setup is shown in the images below. The test module is outlined in yellow. The pyranometer and windspeed sensor can be seen near the top of the test array. The ambient temperature sensor was mounted behind the test array.

The test module(s) were installed on our NMOT test stand as shown in the figures below.
